**Appendix B**  
**Photographic Record**

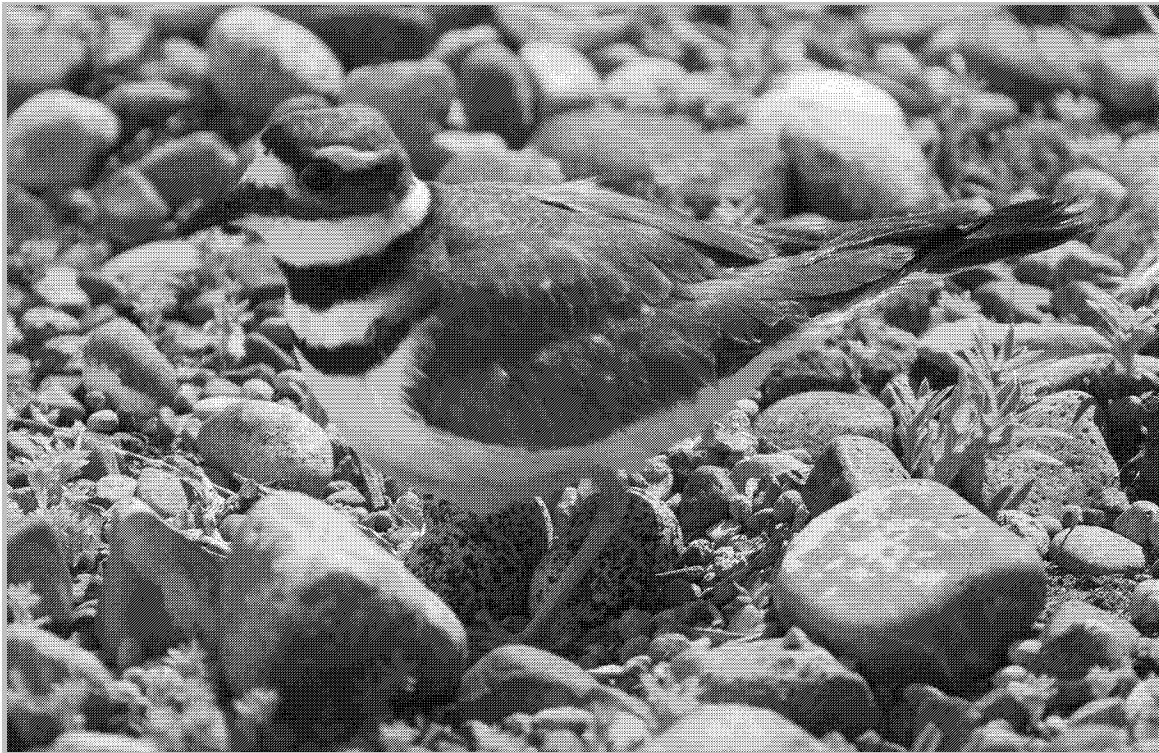
Figure B-1. Killdeer located in Sector 5

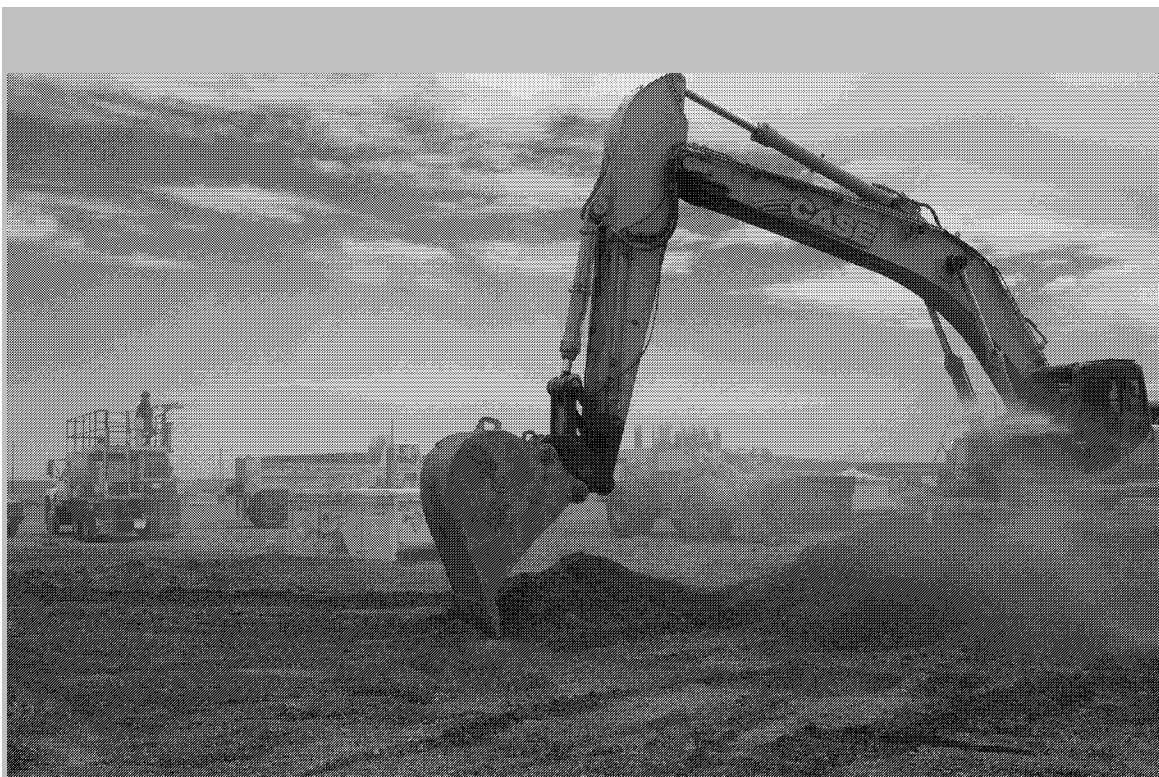
Figure B-2. Excavation of the top 6 inches.

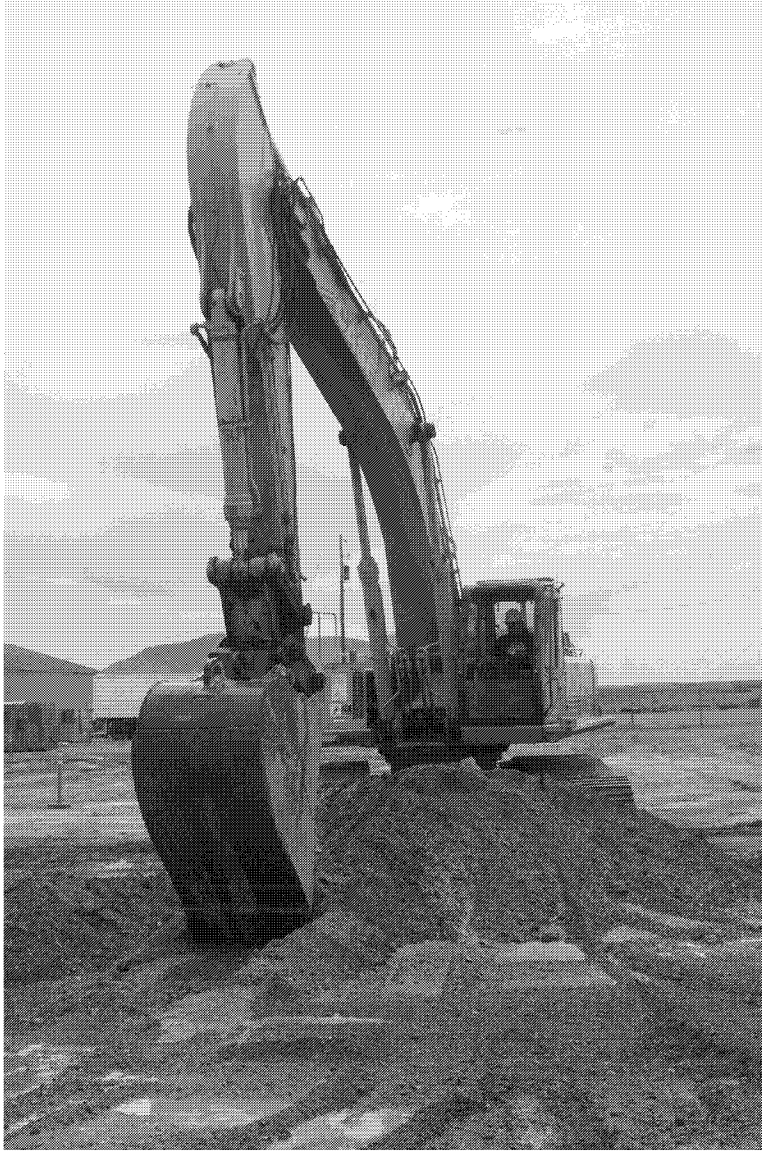
Figure B-3. Excavation continued.

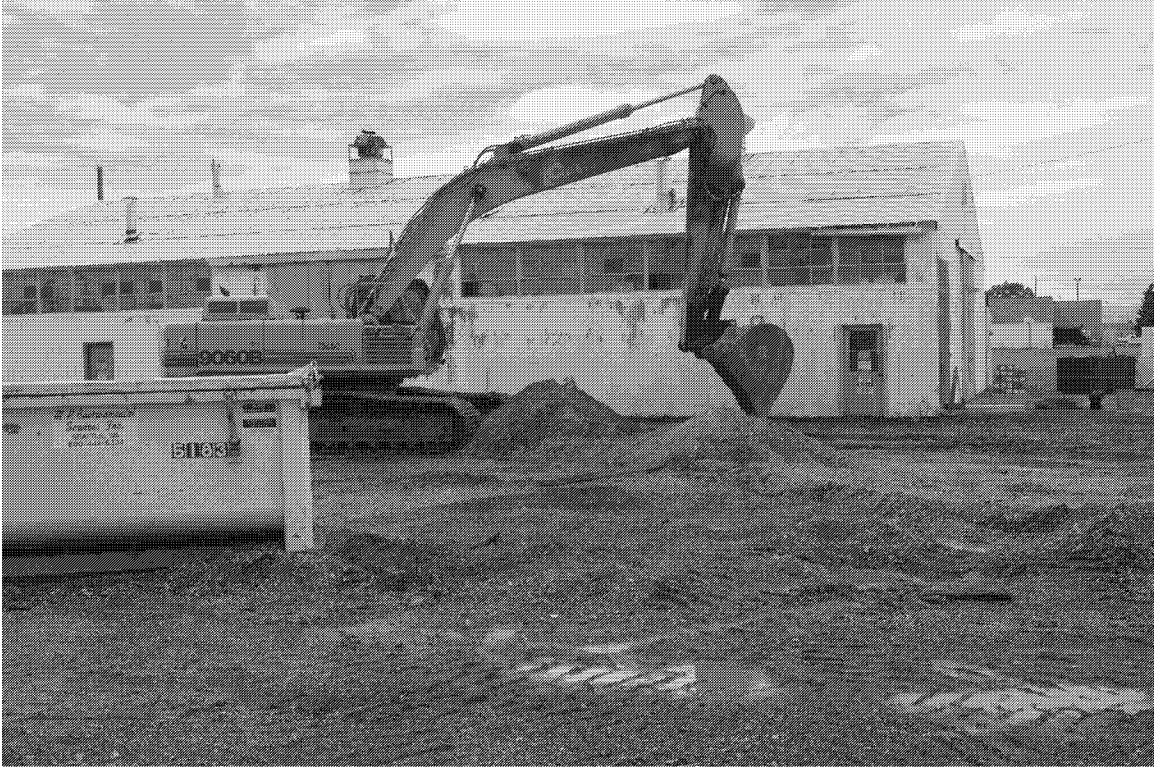
Figure B-4. Excavation on the northeast side of CFA-667.

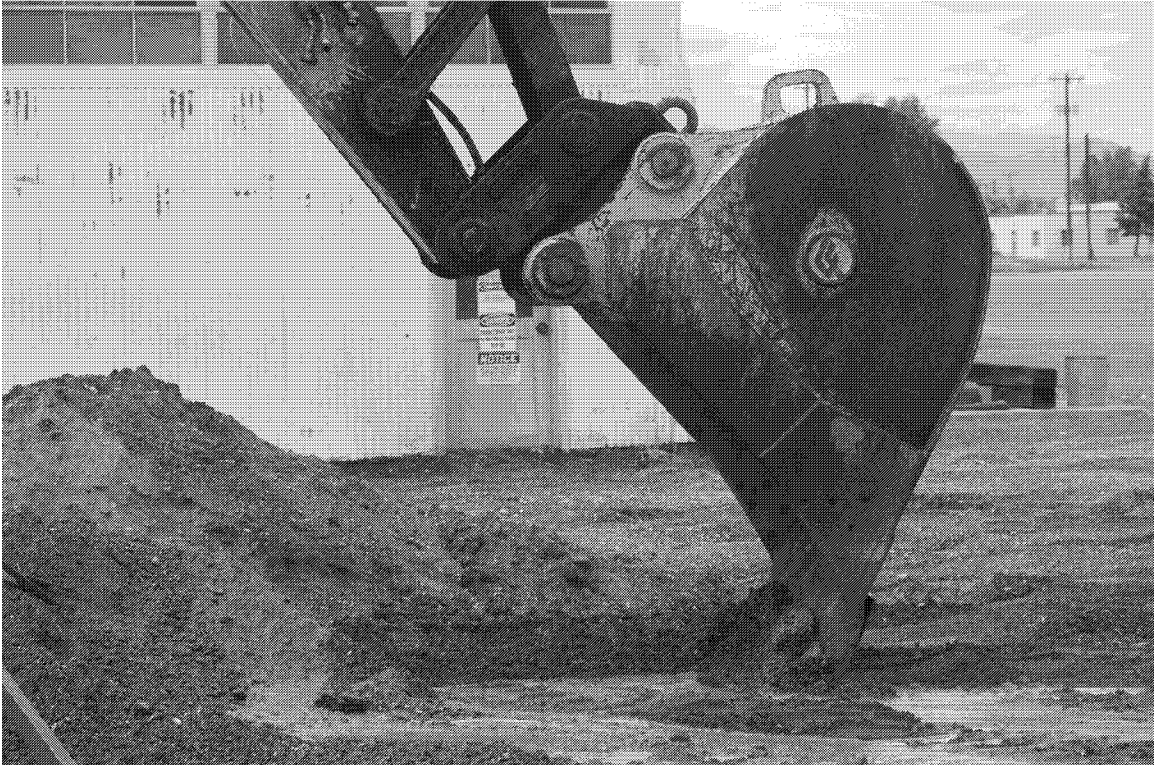
Figure B-5. Excavation continued on northeast side of CFA-667.

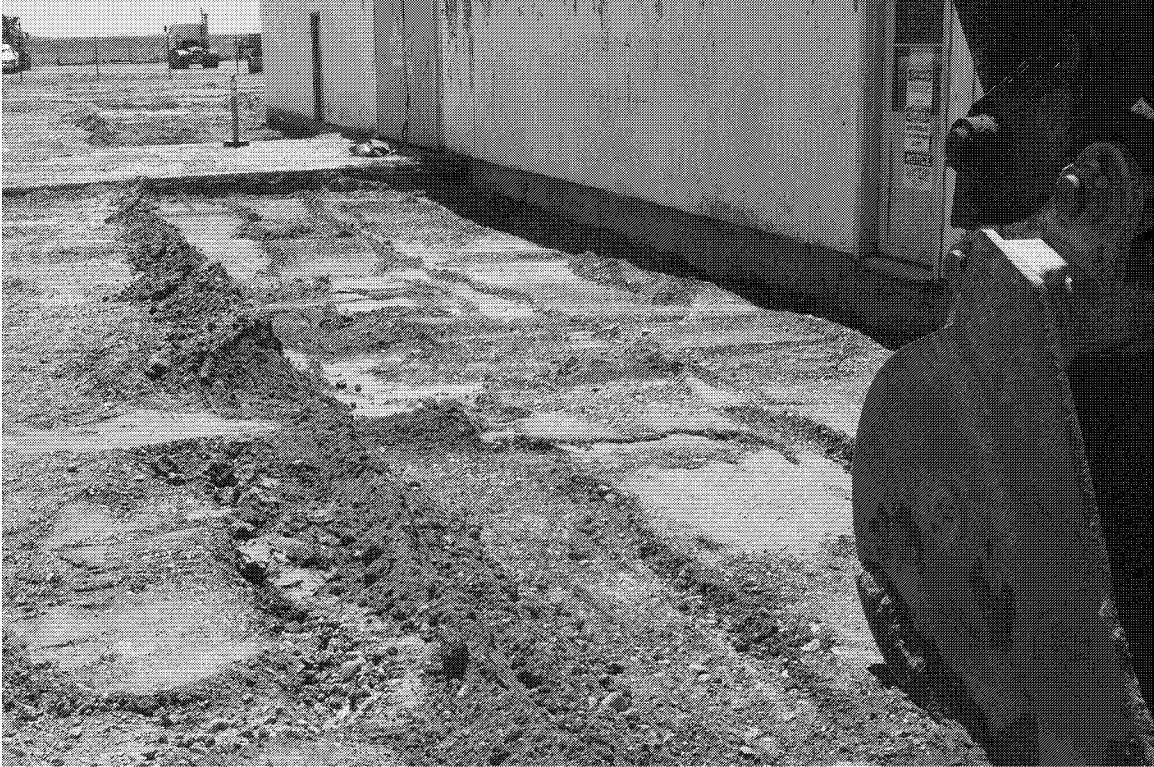
Figure B-6. Excavation continued on northeast side of CFA-667.

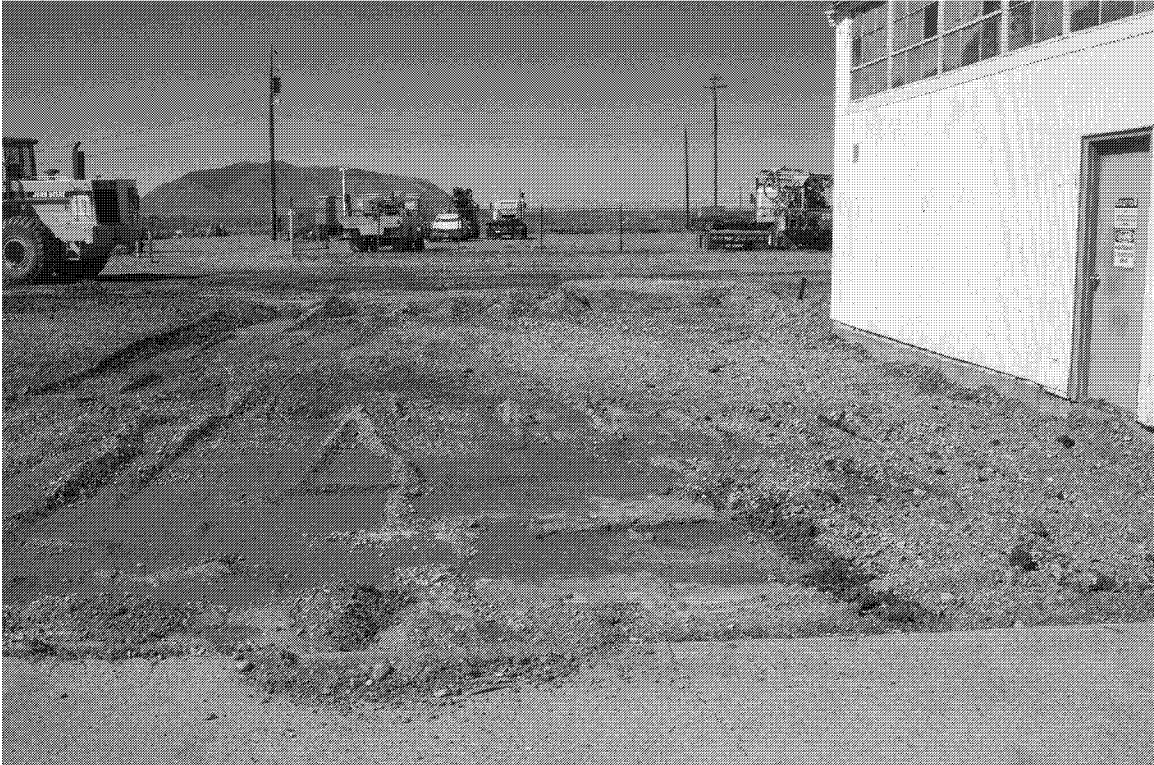
Figure B-7. Excavation of the southeast side of CFA-667.

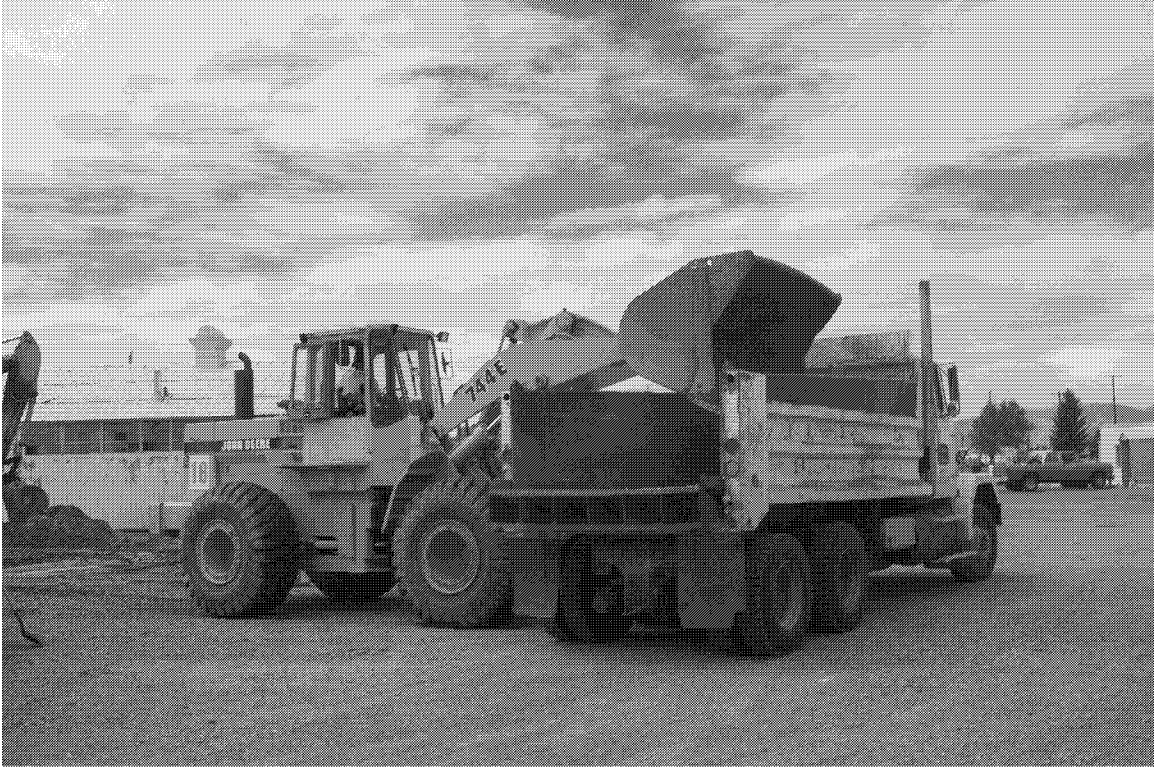
Figure B-8. Loading soil for the CFA landfill.

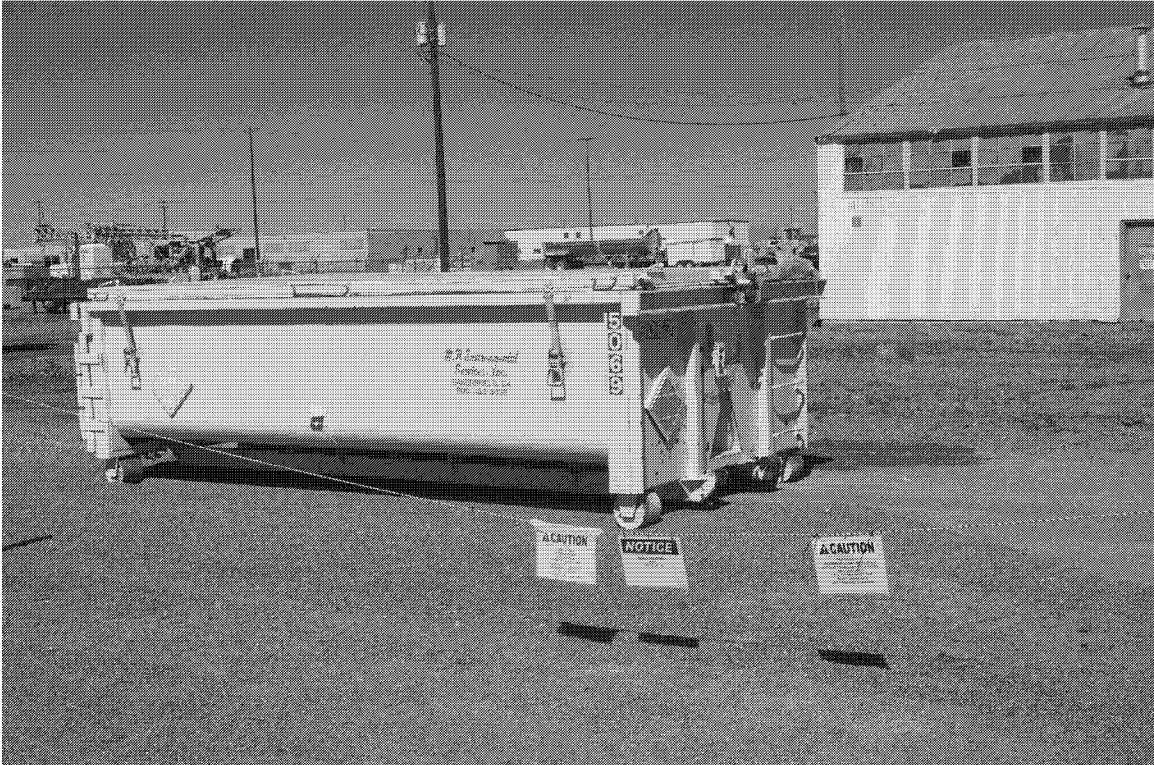
Figure B-9. Roll-off container used for hazardous soils sent off-INEEL.

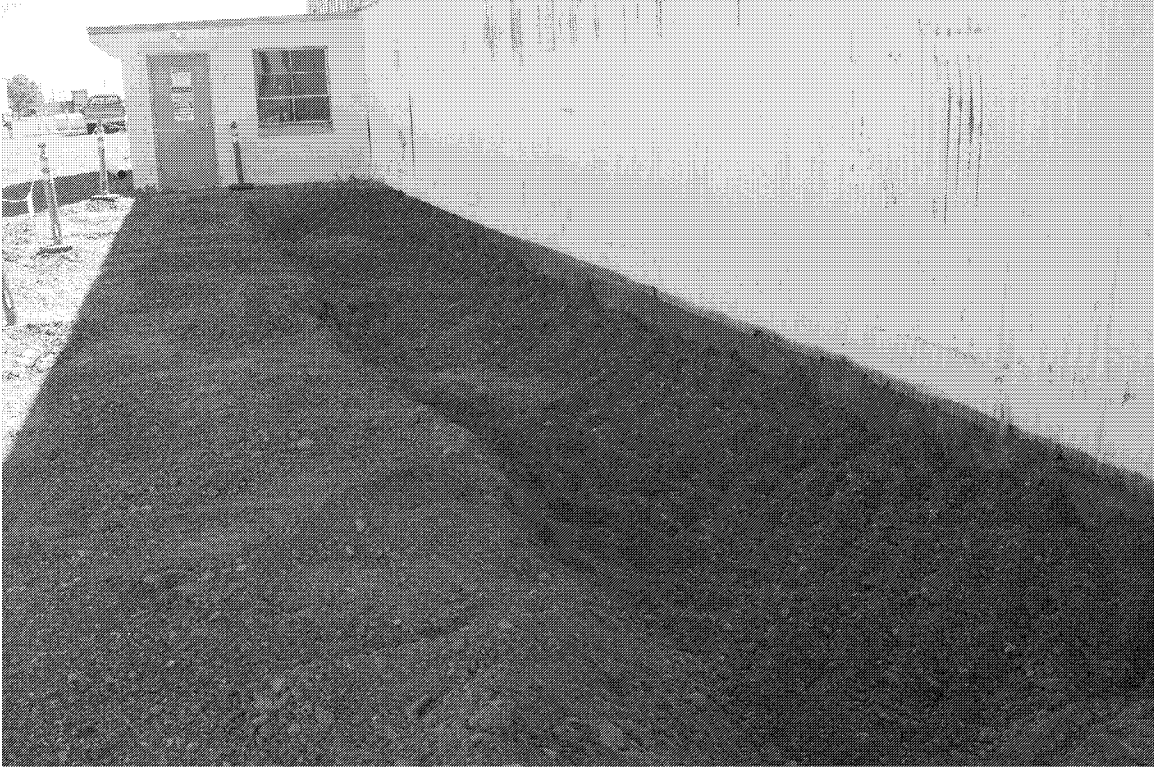
Figure B-10. Excavation of the northwest side of CFA-677 (Sector 9).

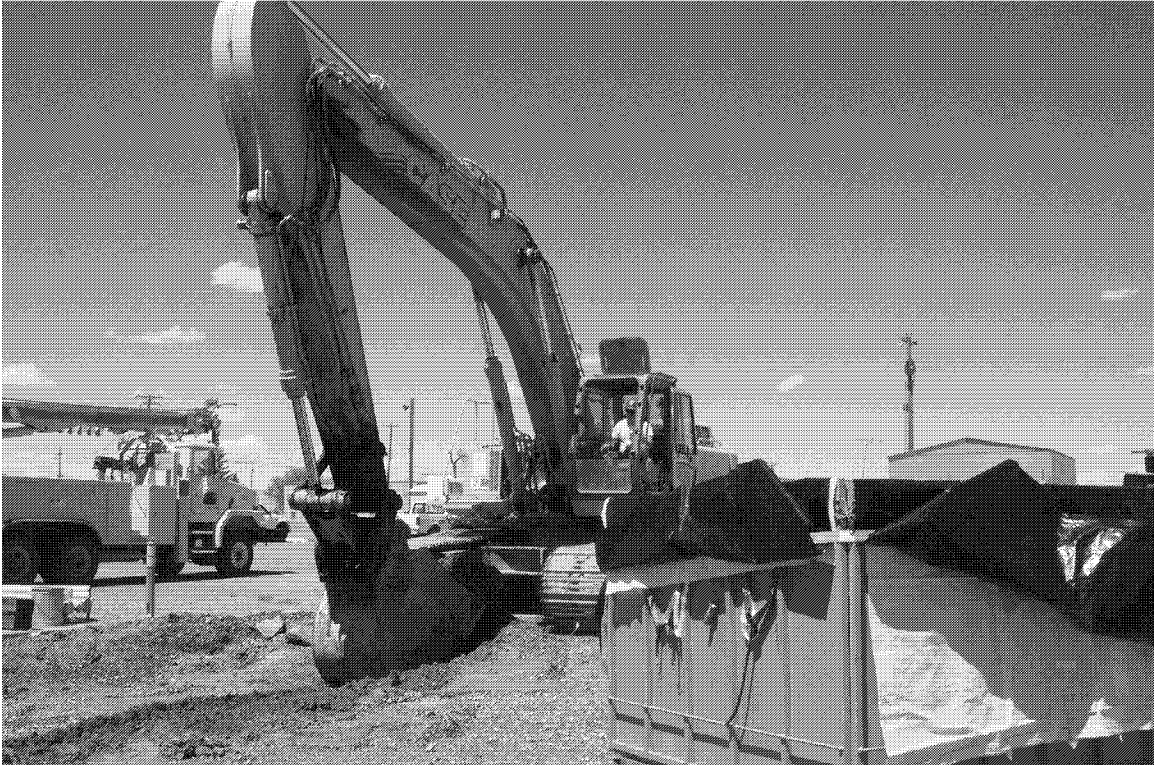
Figure B-11. Excavation of soils to be loaded into soft-sided bags.

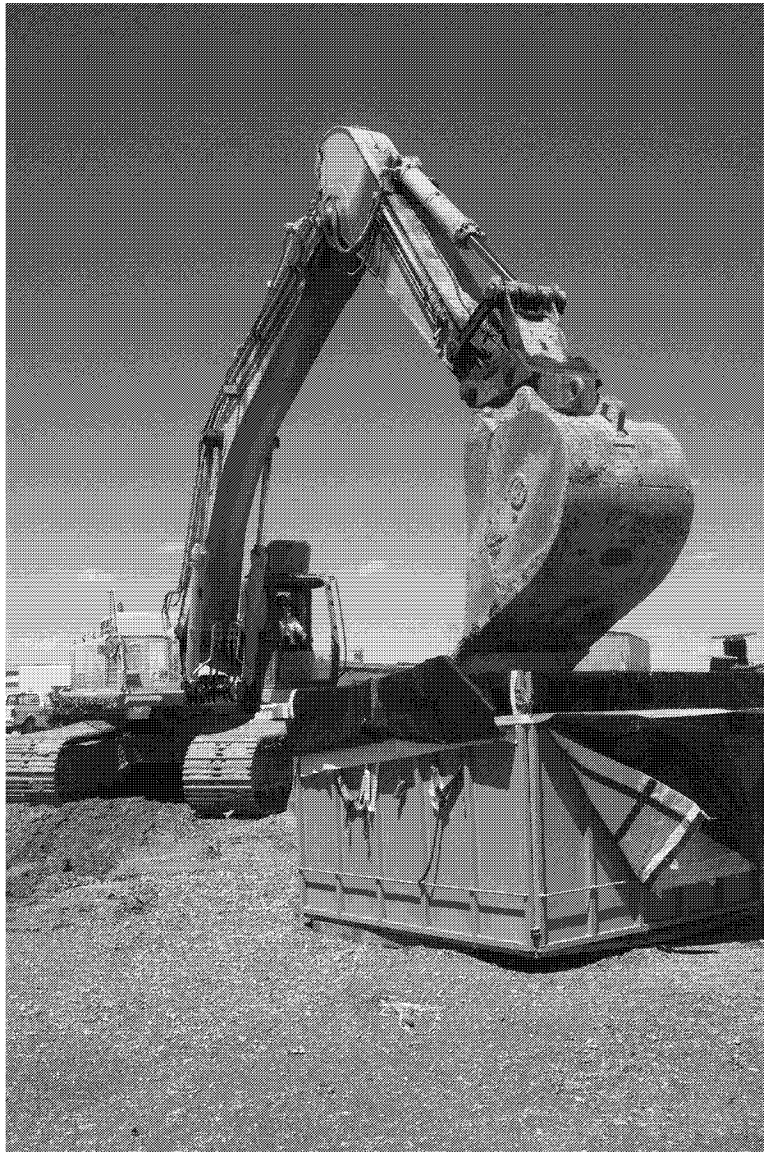
Figure B-12. Loading soft-sided bags.

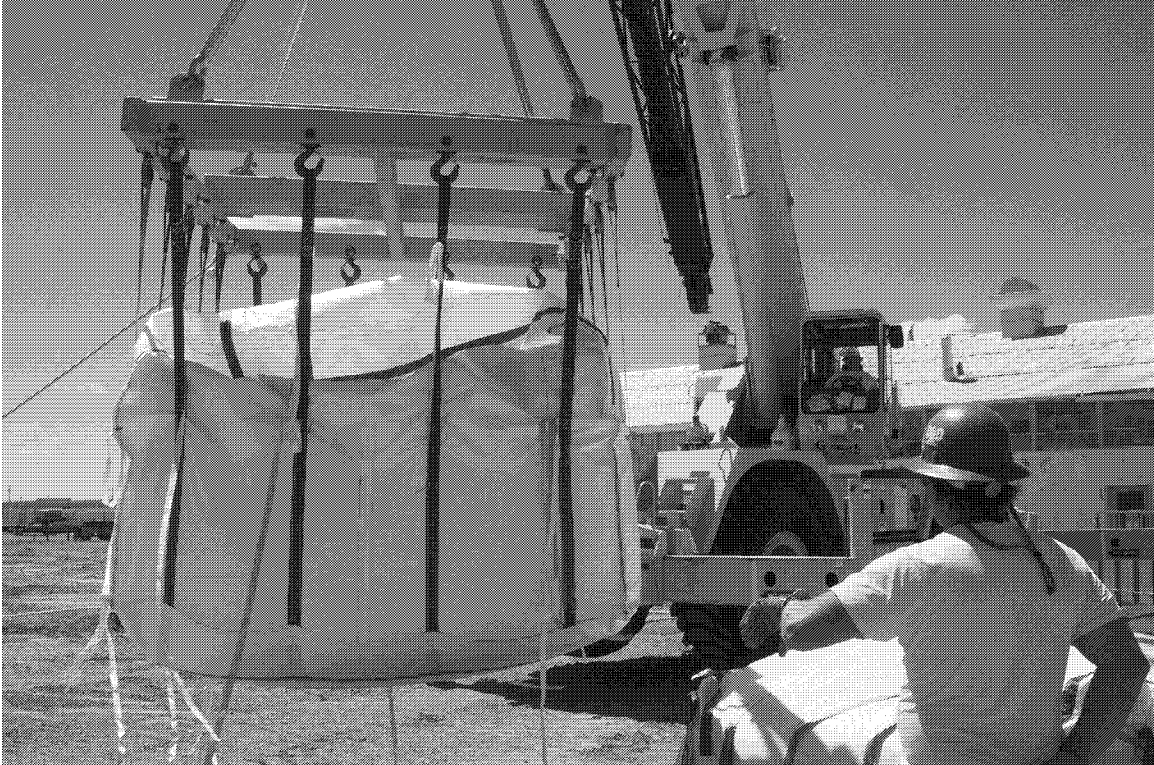
Figure B-13. Moving filled soft-sided bags to temporary storage.

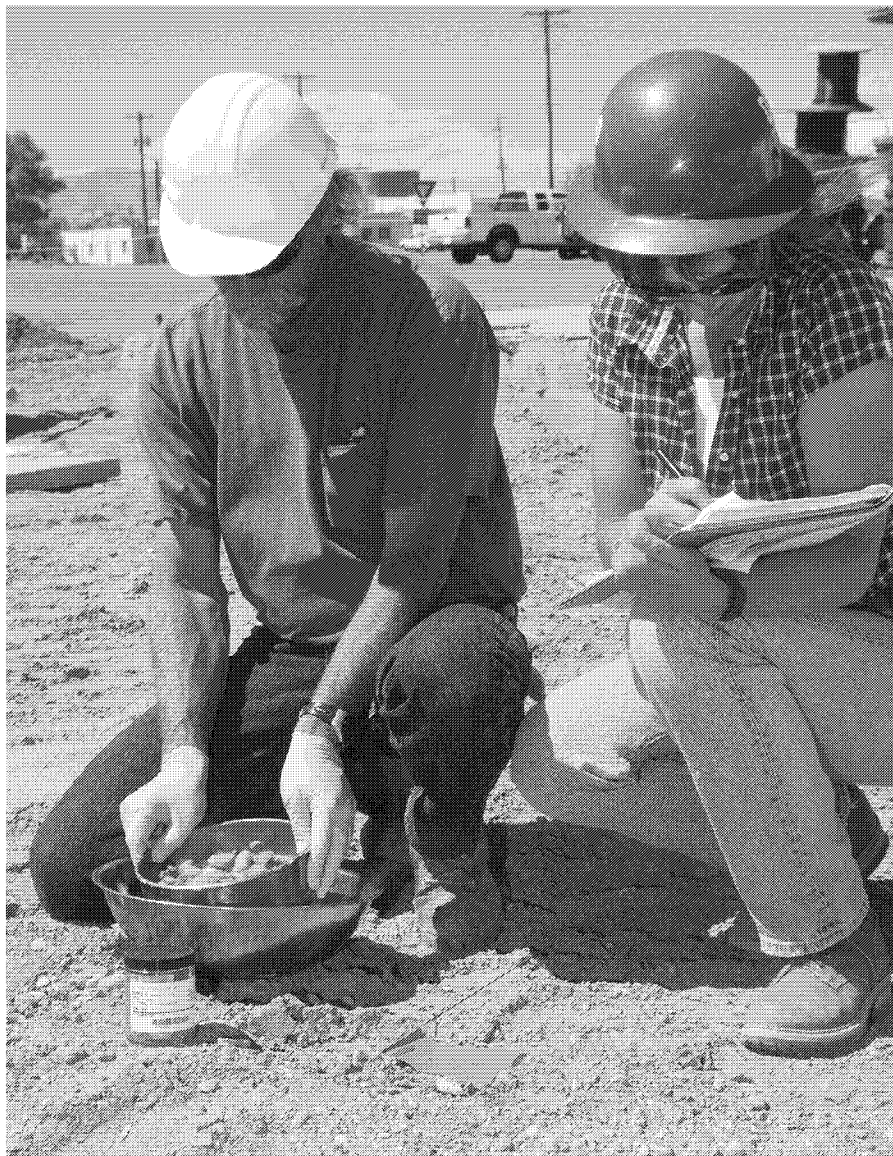
Figure B-14. Composite samples being collected.

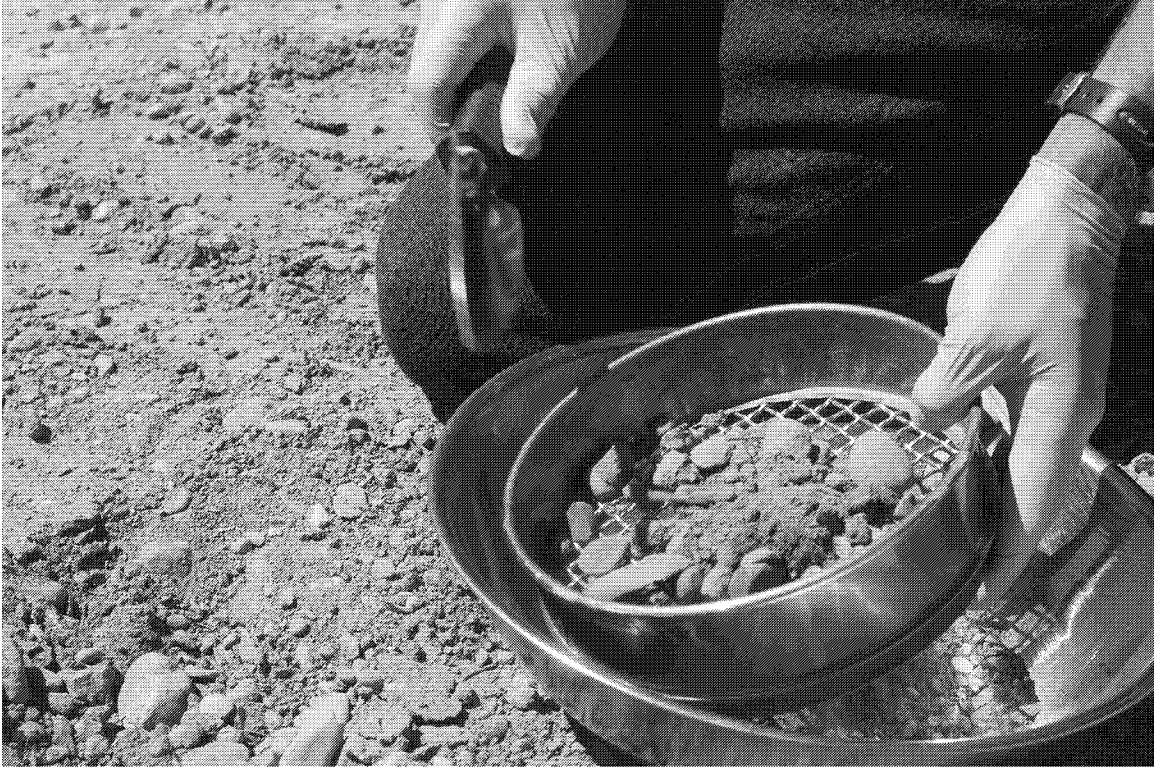
Figure B-15. Sample collection continued.

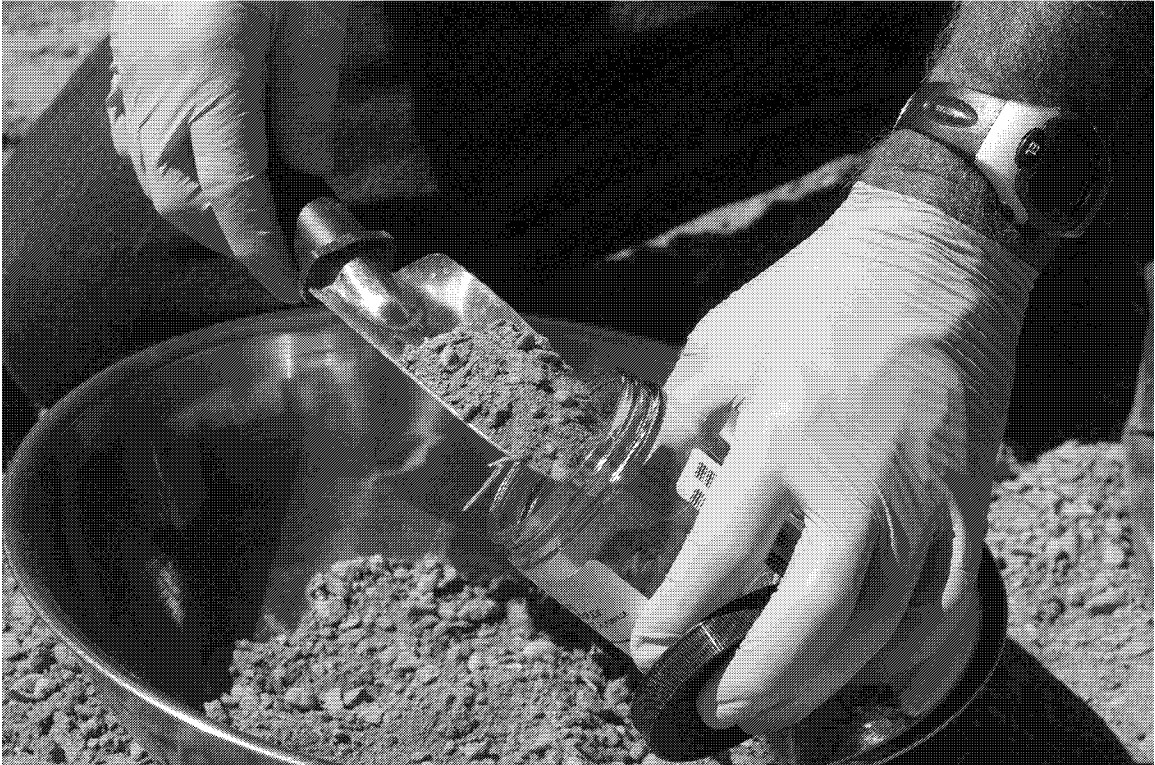
Figure B-16. Sample collection continued.

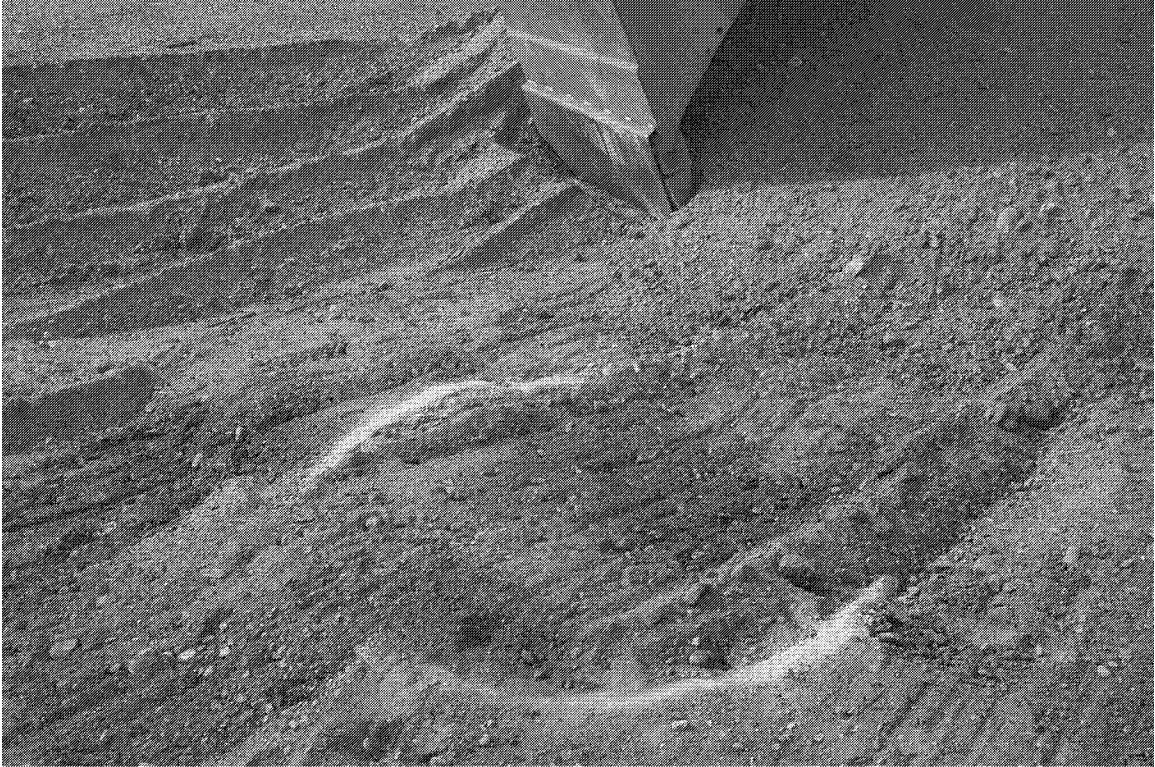
Figure B-17. Discovery of concrete structure.

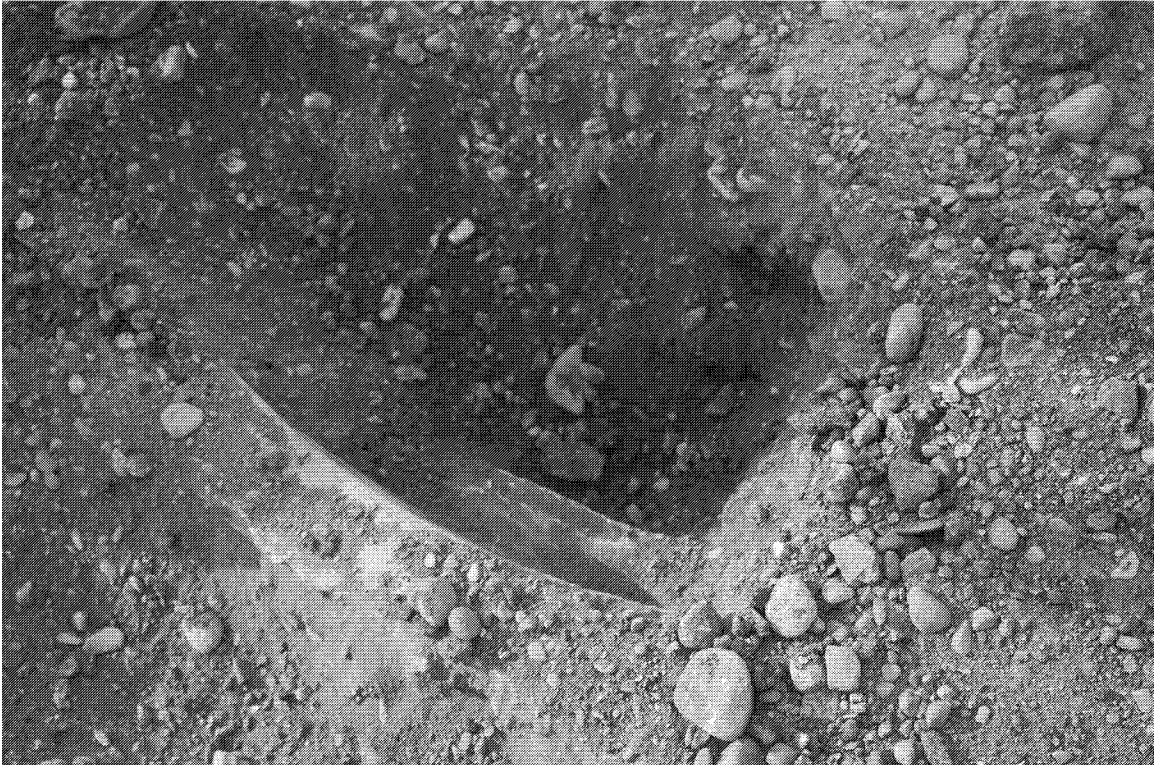
Figure B-18. Excavated lid on concrete structure.

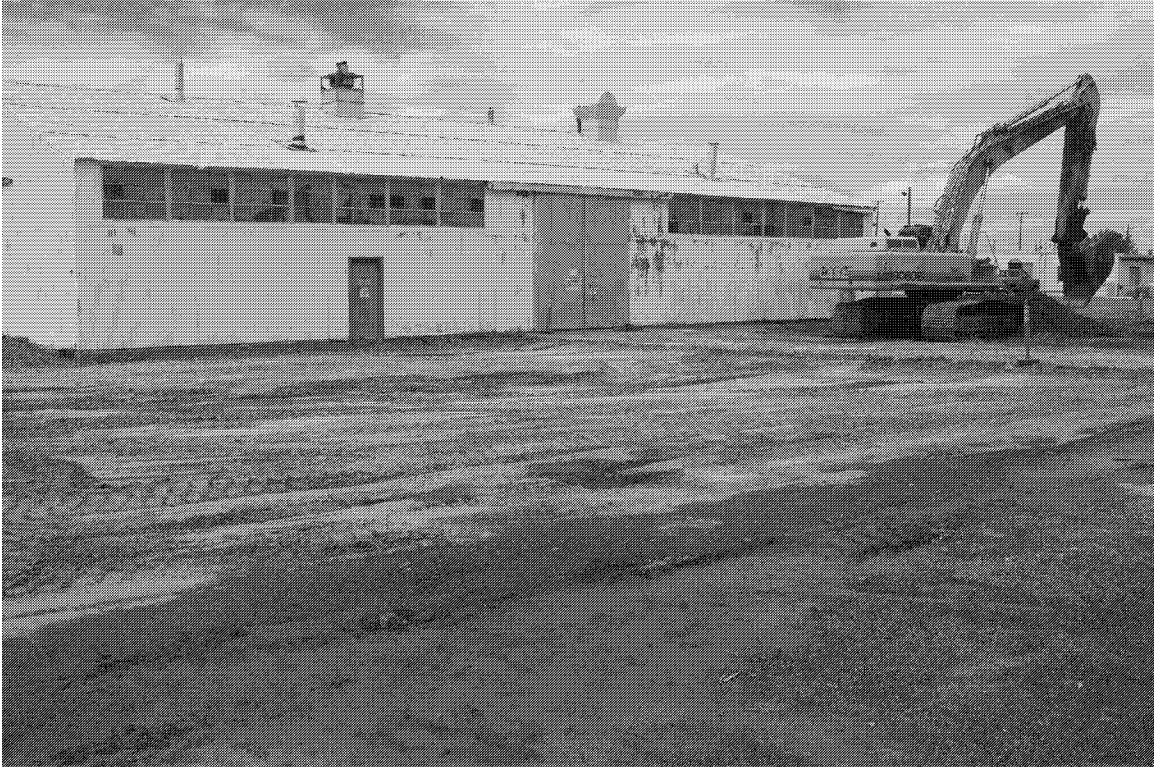
Figure B-19. Restoration continued.
